Hideaway Beach North Beach Project

- Emergency Structure Project Recap
- Long-Term Project
- Synergy with Collier Creek Dredging Project

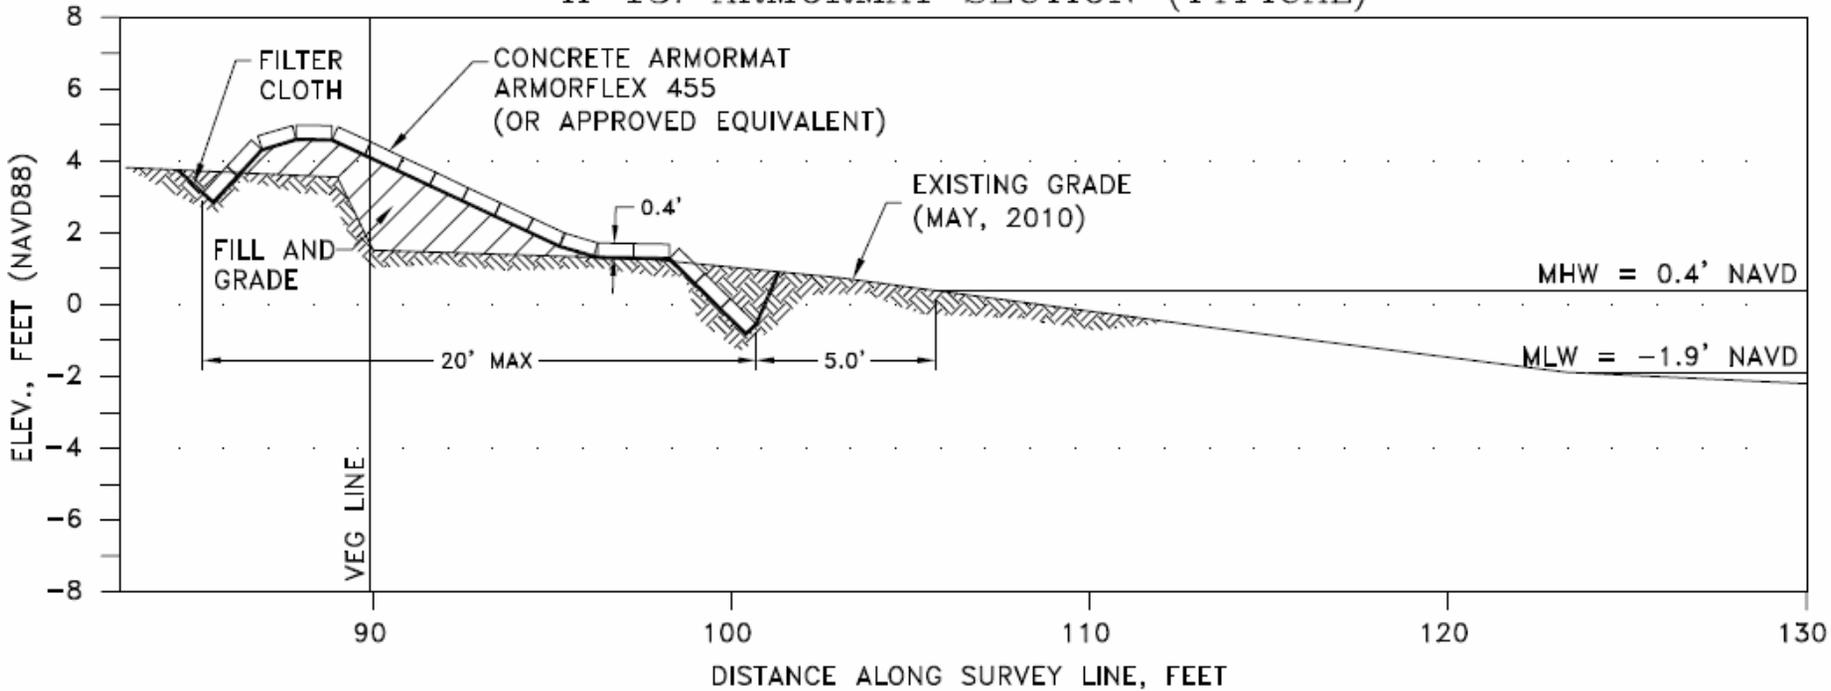
H-13: ARMORMAT SECTION (TYPICAL)

Alternative Design

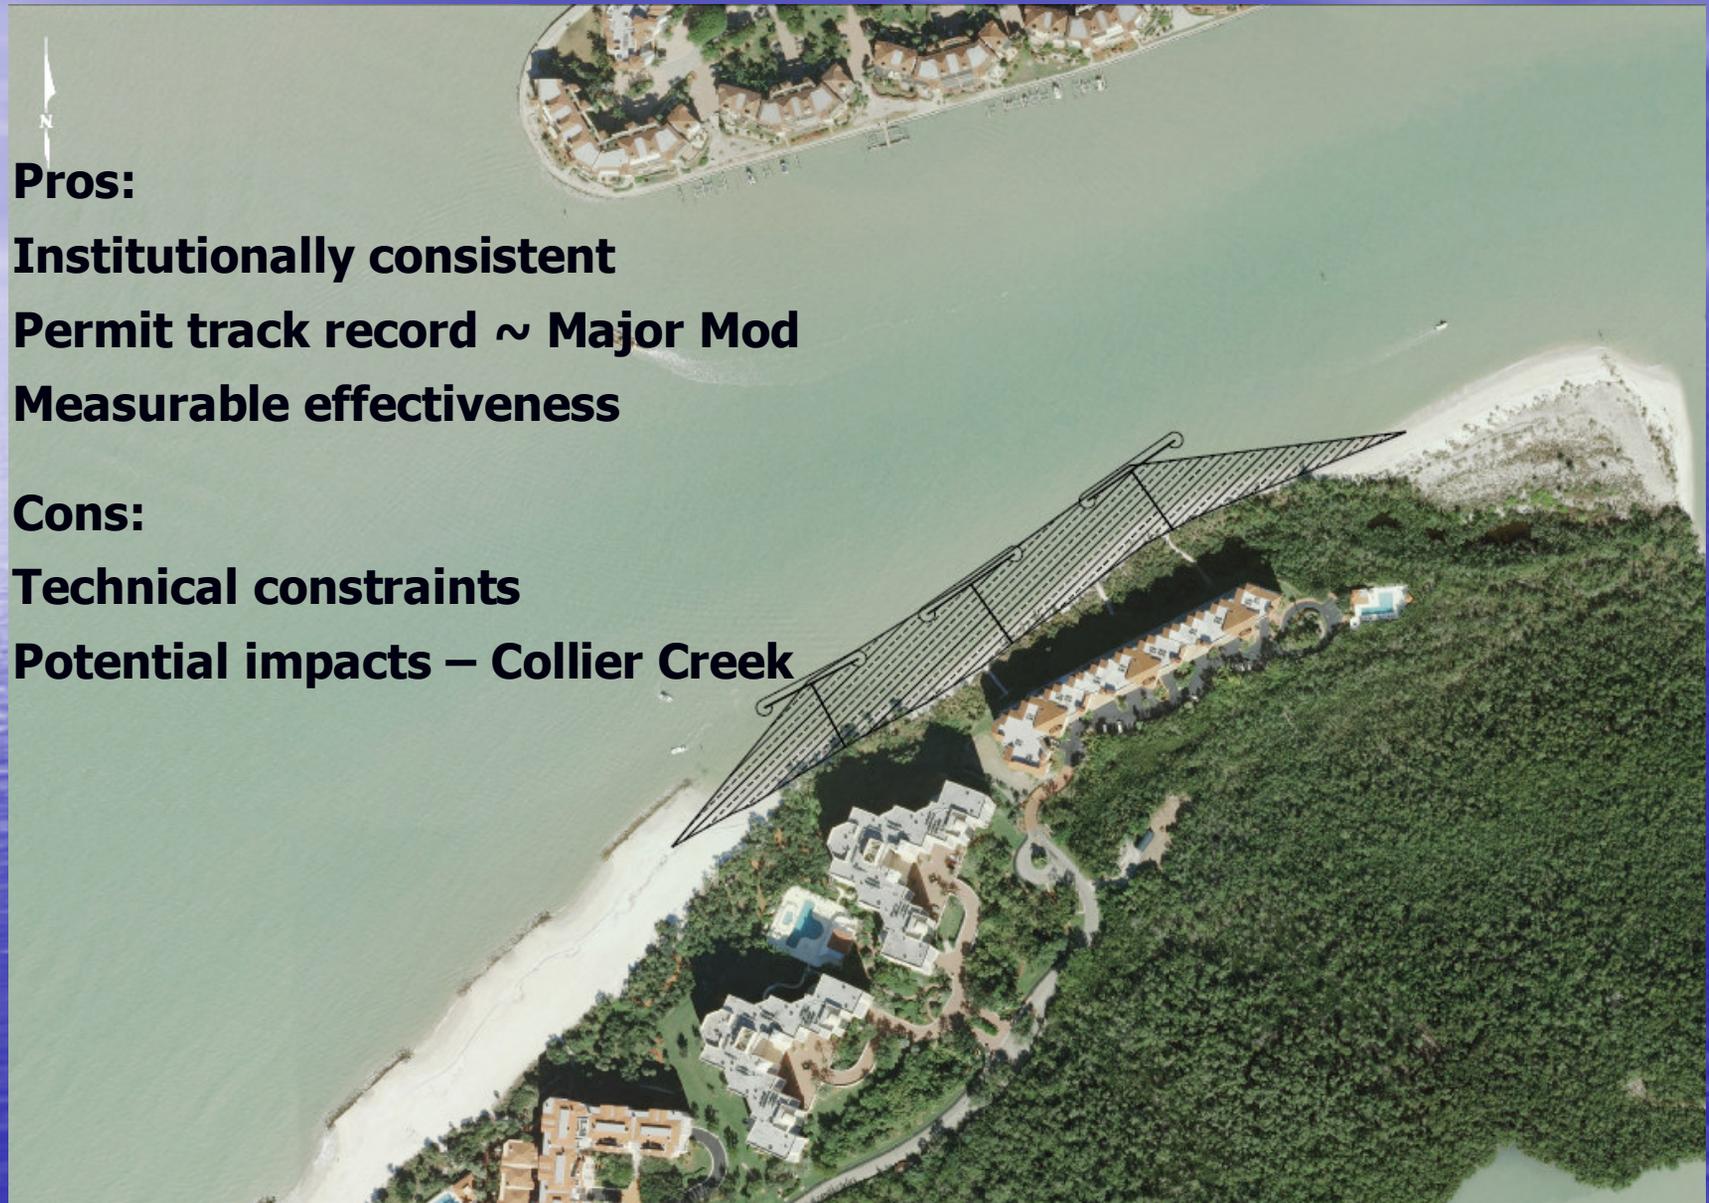
Beach Fill with T-Groins

Pros:

Institutionally consistent

Permit track record ~ Major Mod

Measurable effectiveness

Cons:

Technical constraints

Potential impacts – Collier Creek

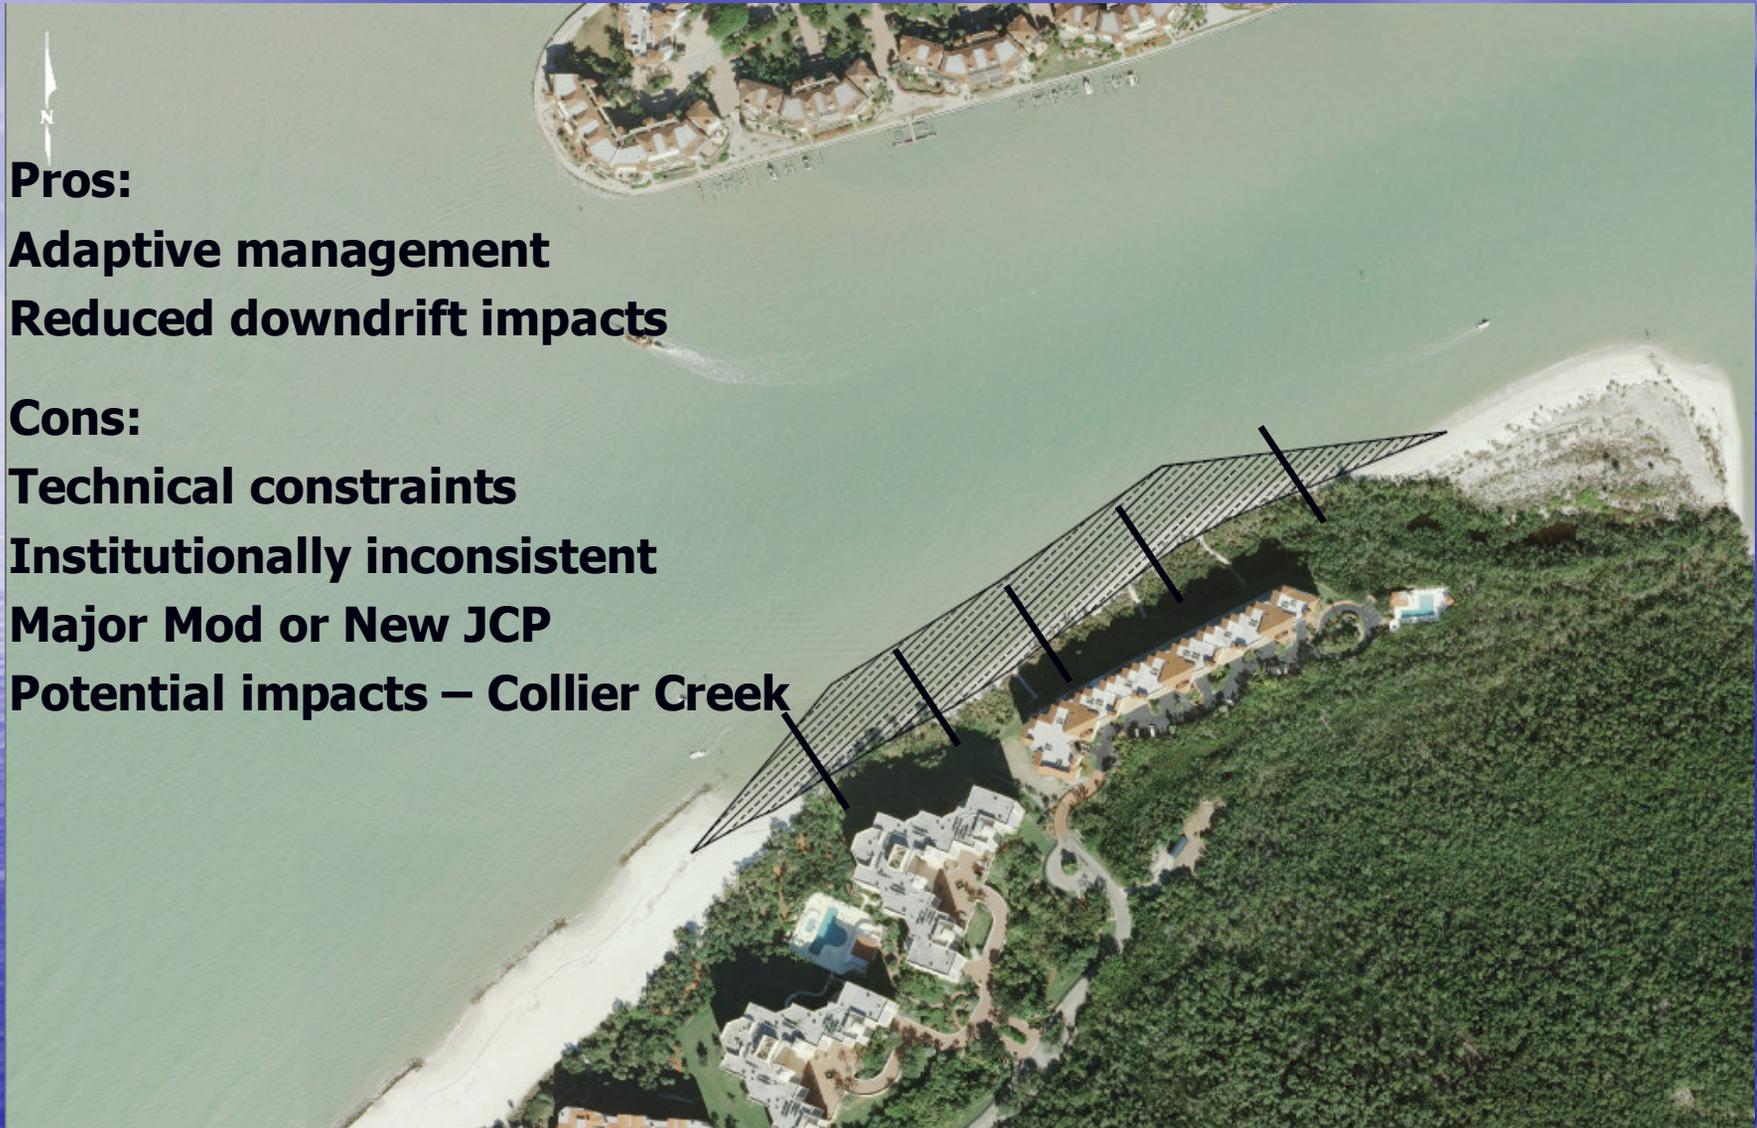
Beach Fill With Permeable Groins

Pros:

Adaptive management
Reduced downdrift impacts

Cons:

Technical constraints
Institutionally inconsistent
Major Mod or New JCP
Potential impacts – Collier Creek

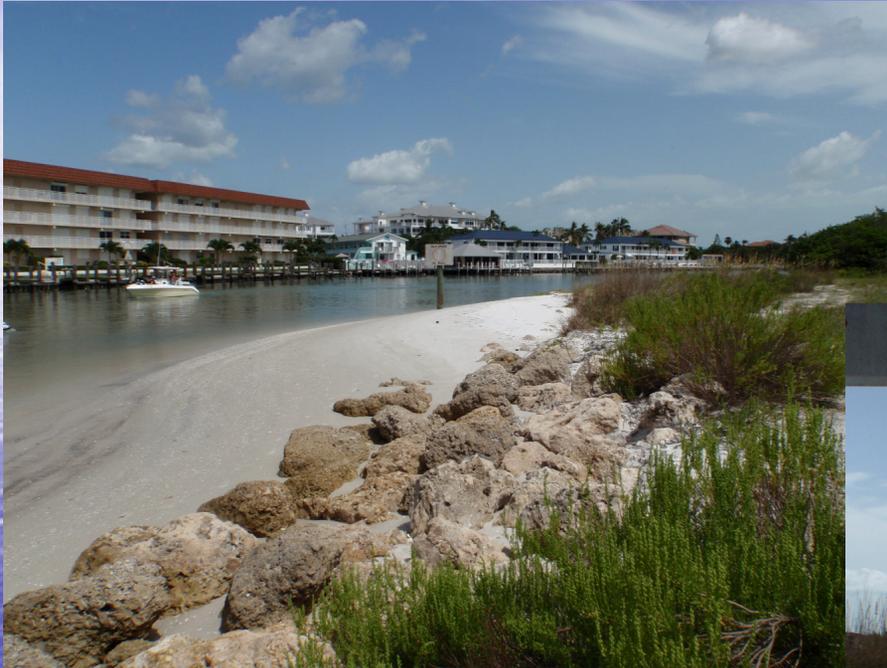
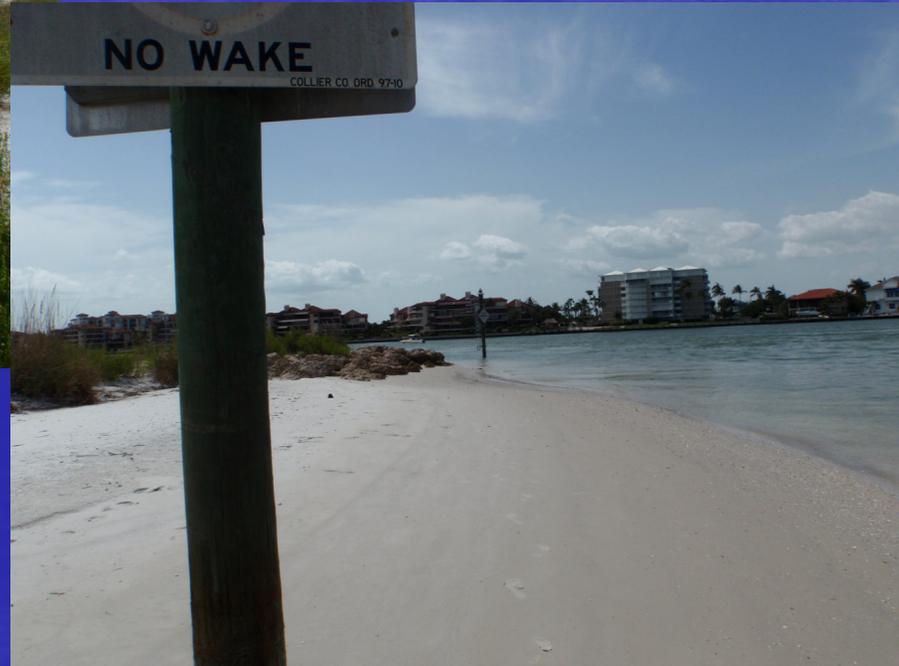
Collier Bay Entrance Channel Emergency Dredging

- Significant Shoaling Measured in Collier Bay Entrance Channel
- Shoal has become Hazard to Navigation
- Safety Concerns for Boating Population on Marco (~ 1/3 of vessels access Gulf)
- Safety Concerns for Transient Vessels
- Damage to Adjacent Waterfront Docks from boat collisions

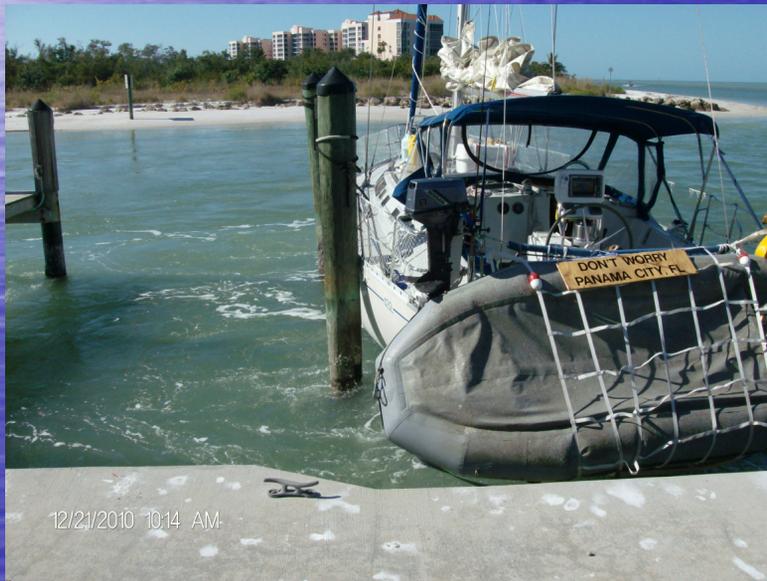
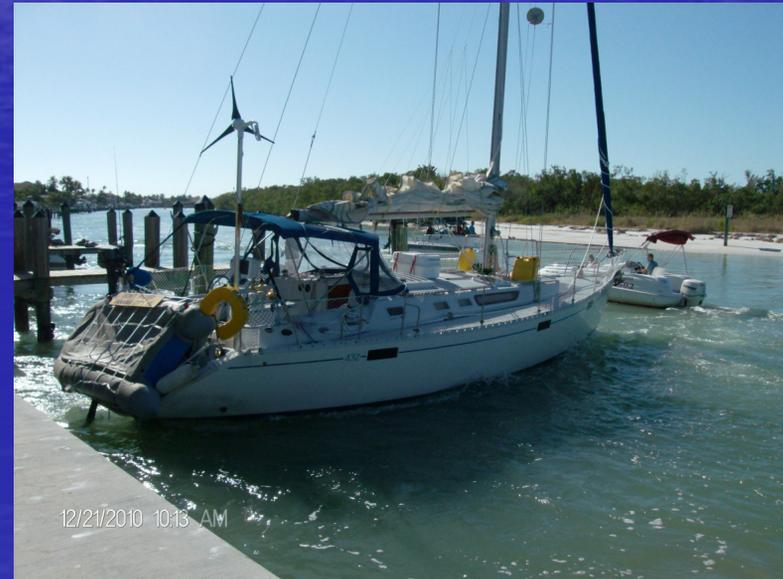
Navigation Hazards

- 43-foot sailboat forced into pier by currents on flood tide. After impact current moved vessel south to pair of mooring piles. Photos show vessel pinned against mooring piles, unable to power free. Damage to boat and pier.
